Case Study

Non-Galvanized Steel Expiring? Collie Street Car Park

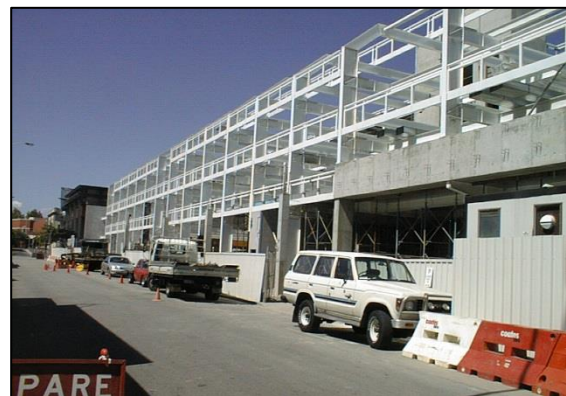
Figure 2: The structural frame of the car park during construction.

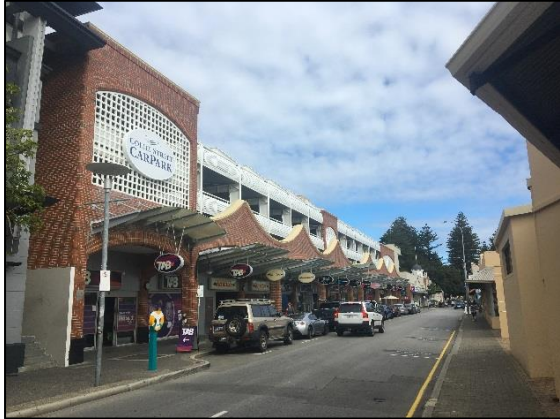
Figure 3: The Collie Street Car Park, June 2016

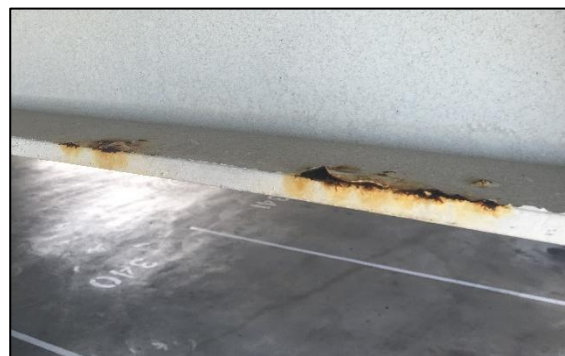
Figure 4: Localised rusting of the structural beam flange under the paint film.

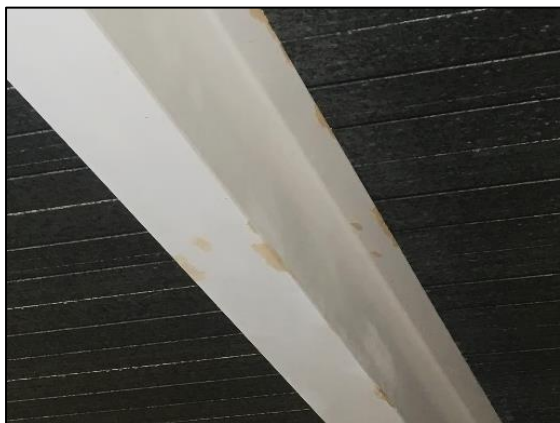
Figure 6: Touched up areas were consistent with locations of visible rust on different floors.

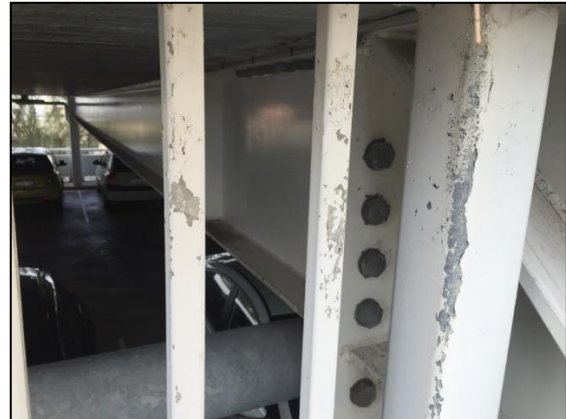
Figure 5: Paint adhesion of the duplex system failing but showing no signs of steel corrosion.

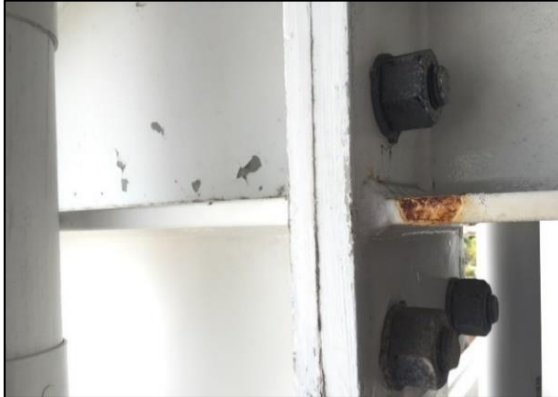
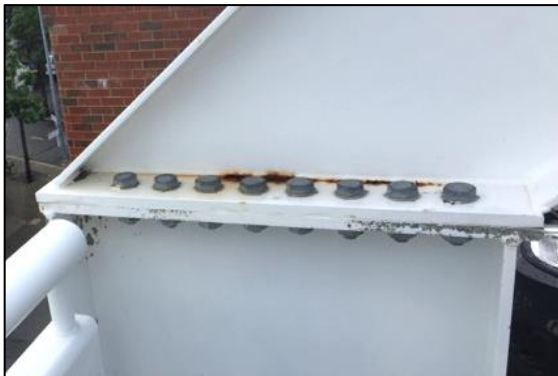
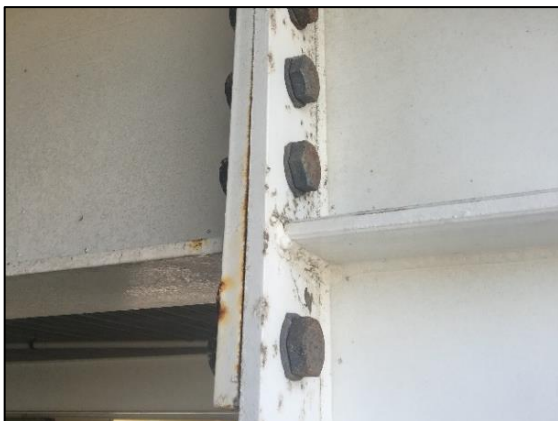
Figure 7: Exposed joints gave a direct comparison between using paint only, duplex systems and HDG to protect the steel when exposed to the same environment. The duplex system protected the base steel although the paint had lost adhesion in some areas. The HDG fasteners had white rust in places, formed by the natural corrosion of the zinc coating but no signs of corrosion of the base steel. The paint only sections showed areas of heavy corrosion of the base steel in some areas, with red rust clearly visible and filiform corrosion likely.

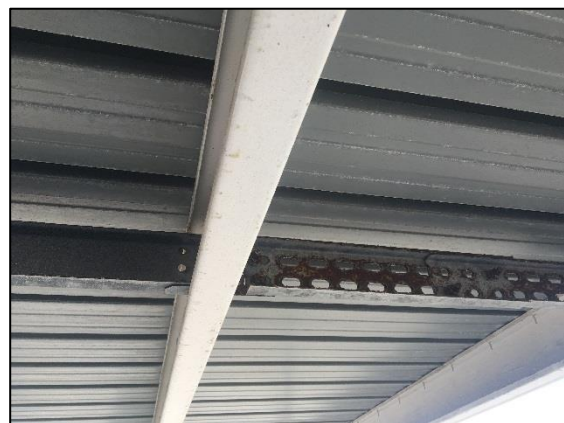
Figure 8: The in-line galvanizing that was sheltered and closest to the coast showed worse signs of corrosion, with an adjacent member slightly further from exposure having no visible red rust.

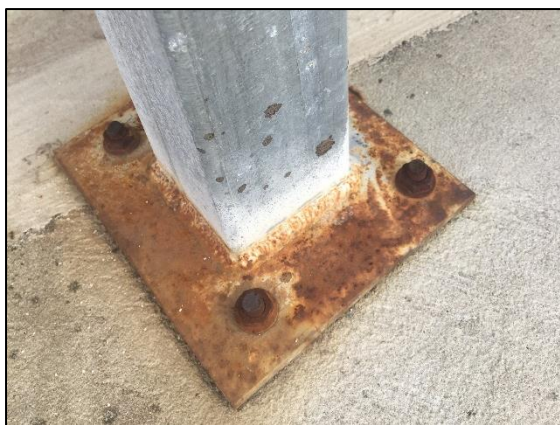
Figure 10: A painted base plate welded to galvanized SHS has corroded, with ponding of water potentially increasing the corrosion rate.

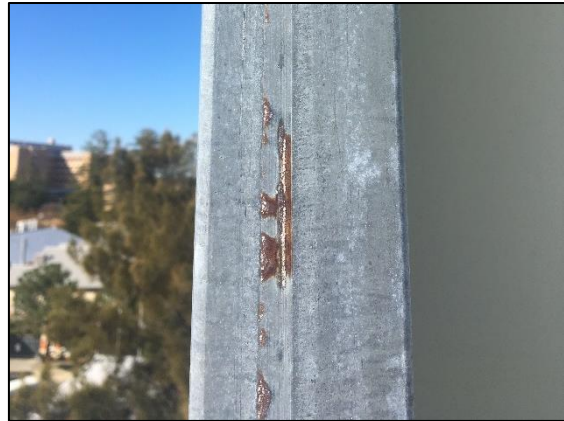
Figure 9: The weld line along the fabricated SHS was corroding earlier than the surrounding galvanizing, indicating an inadequate automatically applied initial repair.

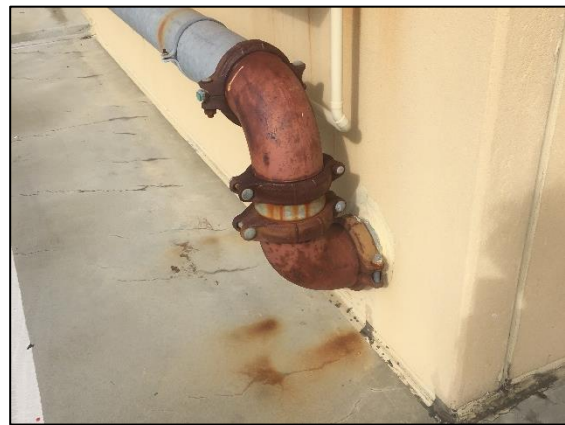
Figure 11: Curved pipe sections to supply water to fire hoses seemed painted only, with rust staining on the ground underneath from corrosion.

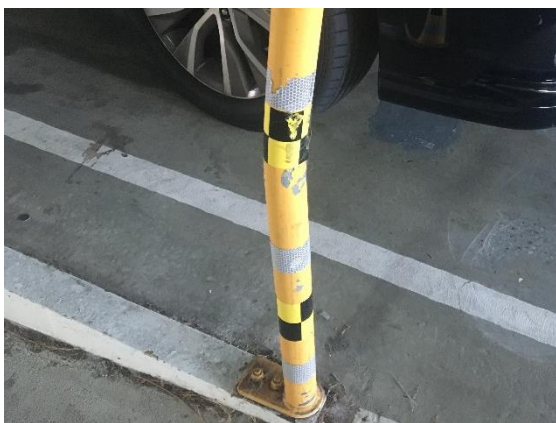
Figure 12: The impact from a vehicle has removed areas of paint, however the galvanizing is still intact and protecting the base steel.

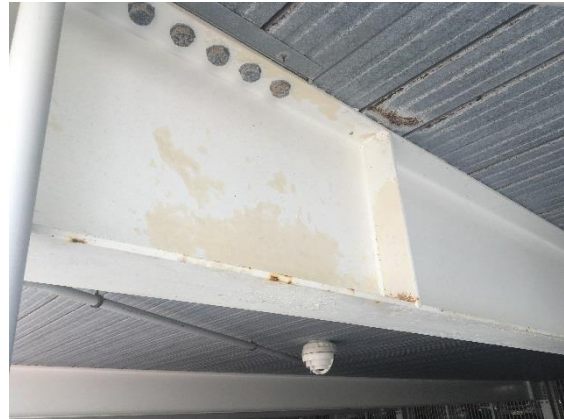
Figure 13: The topcoat of paint seemed to be peeling off the intermediate and the formwork rusting, consistent with water leaking through the concrete.

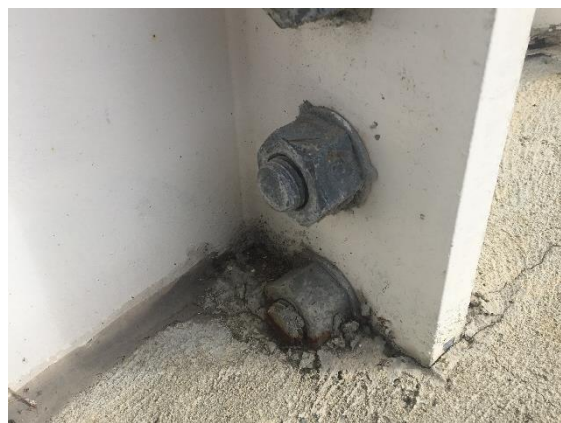
Figure 14: Fasteners have been embedded in concrete on the top floor, leading to ponding of water, crevice corrosion and difficulty when repair is required.

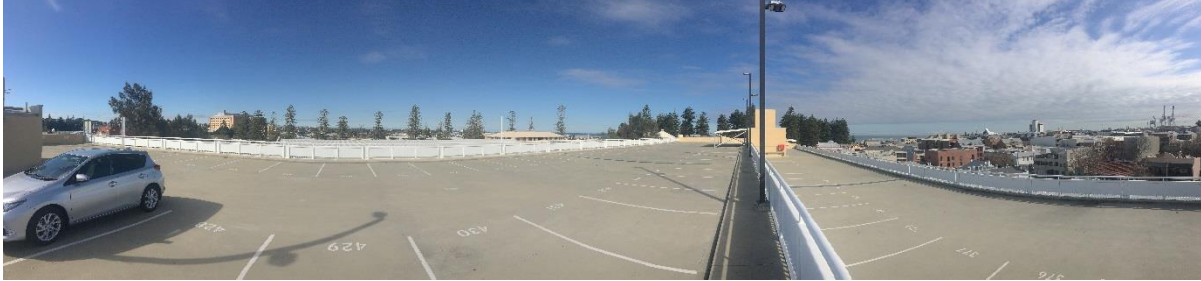
Non-Galvanized Steel Expiring? Collie Street Car Park
