# Case Study

## Duplex System Townsville Railway Station

In 2012, we revisited the site to review the performance of the system.

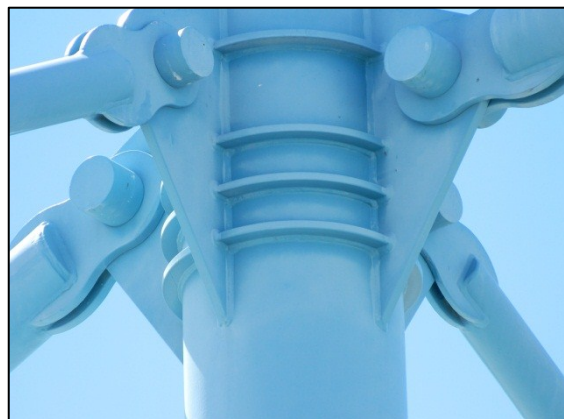
The architects chose to protect the main structural members using a duplex system consisting of a whip blasted hot dip galvanized substrate, followed by a base coat of 100 µm of Amerlock 400 and the finishing aesthetic finish of 45 µm of Lusterthane 988 in 'Blue Weave'.

In August 2012, after around 10 years of service, the duplex system had withstood the environment very well and there was no sign of corrosion of the steel structural elements. Adhesion of the paint to the HDG substrate had remained strong, although the invariable tough treatment from passengers had damaged the paint in a small number of areas. However, the hot dip galvanized coating under the aesthetic paint meant that the steel substrate had not corroded and the commonly occurring (and unsightly) rust staining had been avoided.

This result is a demonstration of the benefit of the duplex system where aesthetics are important. No stand-alone paint system could have been designed to eliminate this damage. In this case, the hot dip galvanized coating has protected the steel and the paint can easily be touched up if it is required to maintain the aesthetic effect.

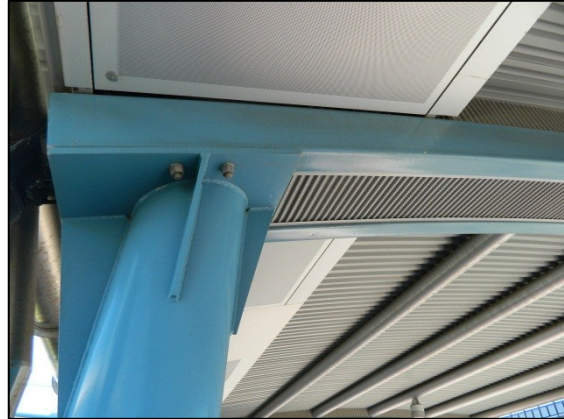
The concrete footing supporting the steel column also shows damage to both the

paint and the concrete from abrasion and heavy knocks at the corners. Again, these can be easily repaired and the damage to the concrete is not considered critical to the use of the structure.

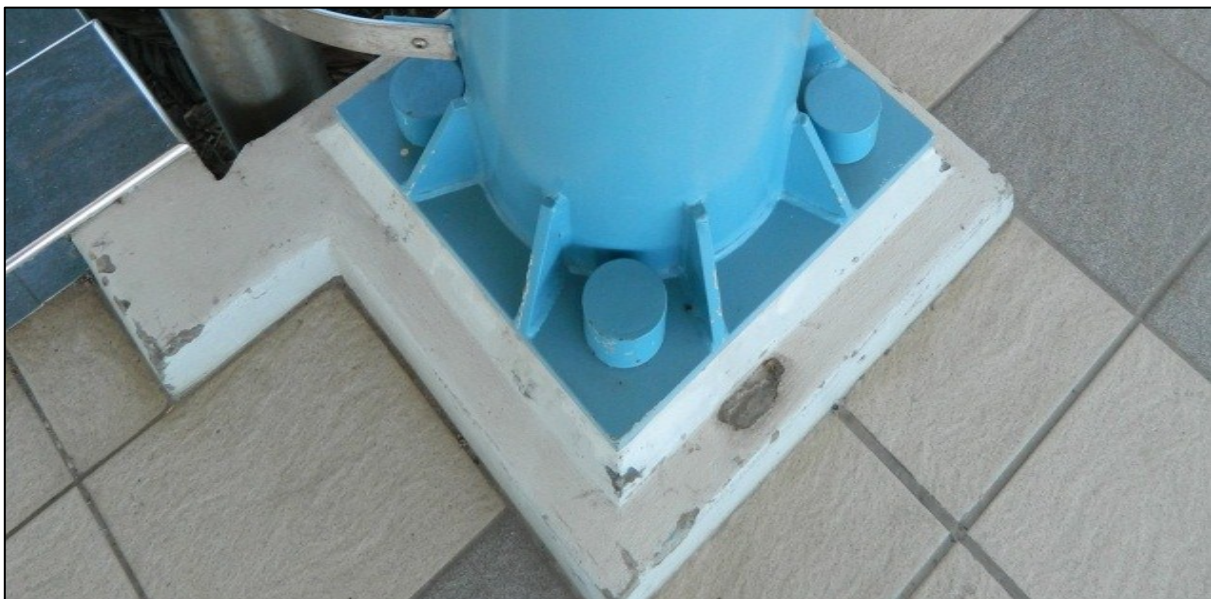
Importantly for an environment close to the sea and with high humidity, there is no evidence of corrosion in the unwashed areas under the eaves.

The stainless steel gutters and decorative items do show corrosion damage and these will need to be repaired to ensure that premature failure does not spread to the main structure. The reason for this

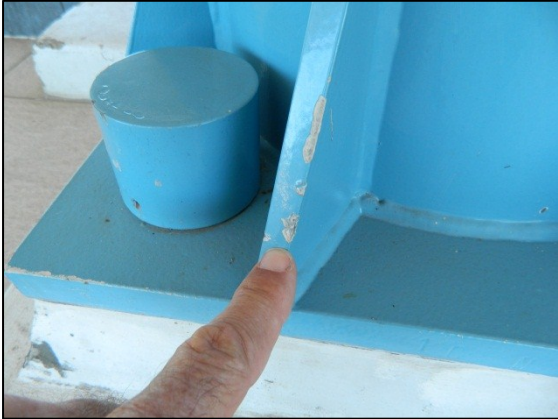
stainless steel corrosion may well be related to incorrect specification of the material.

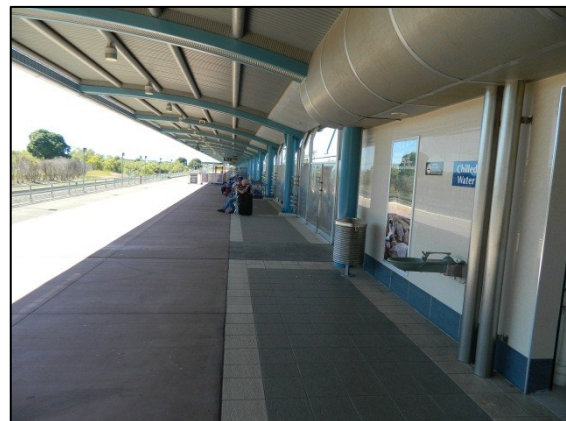
However, in some cases the combination of a well-designed and properly applied paint over a suitably prepared hot dip galvanized article can provide both improved aesthetics and an increased protection from corrosion.
