Case Study

Protection for well into the future

Located near the centre of Dubbo, NSW lie two large new hot dip galvanized (HDG) roof canopies perched over two new HDG fenced enclosures within a newly developed park. Passers-by are immediately intrigued and regularly stop to learn more about the role this site played in the history of the town of Dubbo.

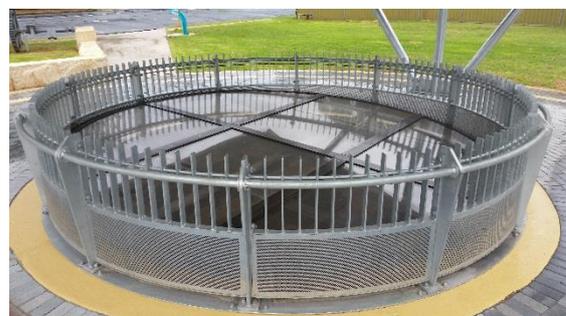
By the early 1900s, Driftwell 1 alone could no longer adequately supply the growing township's demand and so in 1909 a second well (6 metres in diameter and 21.33 metres deep) was sunk using the "cassion" method next to Driftwell 1.

The two driftwells were then connected so that their combined volume of water could

be pumped out using just a single set of pumps.

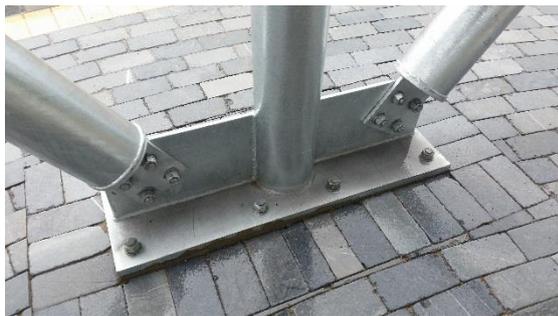
In early 2014 the decision was made to dramatically upgrade the existing driftwell site to help highlight the integral role the driftwells played in the history of water supply within Dubbo.

At a cost of \$510,000 the project was completed in February of 2016.

The upgrade included restoration of the original piston pump while the original steam boiler was also located and renovated to give a fuller historical picture of the site.

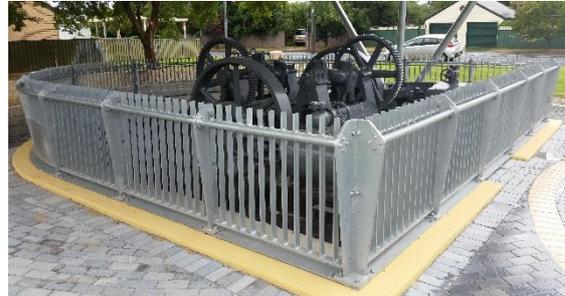
HDG was used extensively in the upgrade of the park.

Being located in a C2 environment the HDG structures will require little maintenance and should protect the steel articles for close to 100 years.

The majority of the connections are bolted allowing for easy galvanizing as well as simple transport and onsite installation. This also eliminated the high cost of any onsite welding and allows for easy disassembly and replacement should it be required.

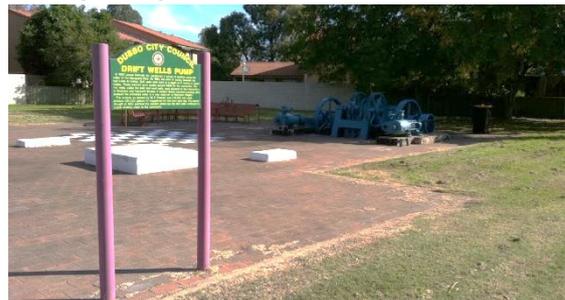
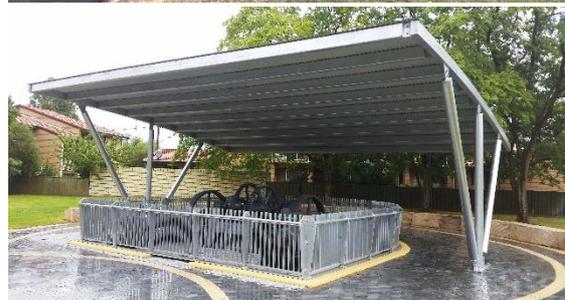
Comparison of the old site and the new upgrade showing the piston pumps⁴
