Hot Dip Galvanizing The best protection inside and out

Hot dip galvanizing process

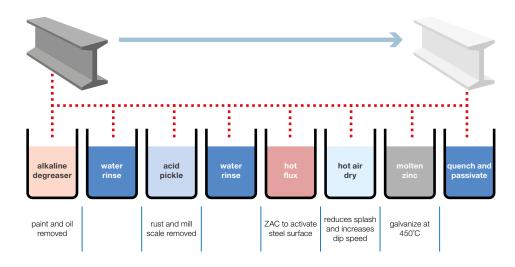
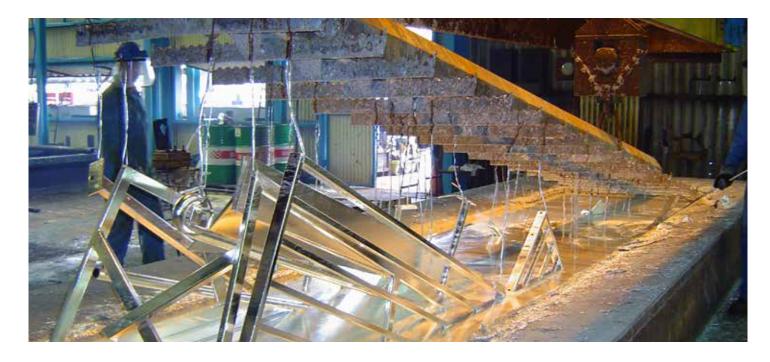
The hot dip galvanizing process starts by suspending steel articles and dipping them into a series of cleaning baths. Once cleaned, the steel is lowered at an angle into a bath of molten zinc. Immersing the steel on an angle allows air to escape from vented tubular shapes or pockets that may be within the design and permits the molten zinc to displace the air. The steel reacts with the molten zinc to form the galvanized coating. After being withdrawn from the zinc, the final step in most hot dip galvanizing processes is a quench to promote passivation of the zinc surface.

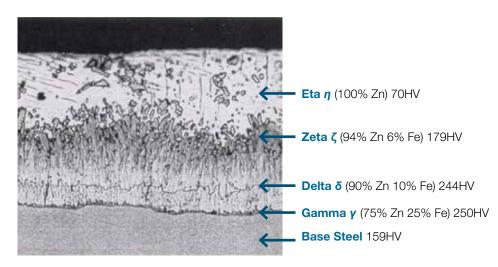
The formation of the galvanized coating on the steel surface is a metallurgical reaction, where the zinc and steel combine to form a series of hard intermetallic layers. The outer layer is, typically, 100% zinc which covers the surface after withdrawal from the molten zinc bath.

The gamma, delta and zeta alloy layers are all harder than the base steel they are metallurgically bonded to, which gives hot dip galvanizing its great abrasion resistance.

The galvanizing process naturally produces coatings on the corners and edges which are at least as thick as the coating on the rest of the article. As the reaction between iron and zinc is a diffusion reaction, the crystalline structure of the coating forms perpendicular to the steel surface.

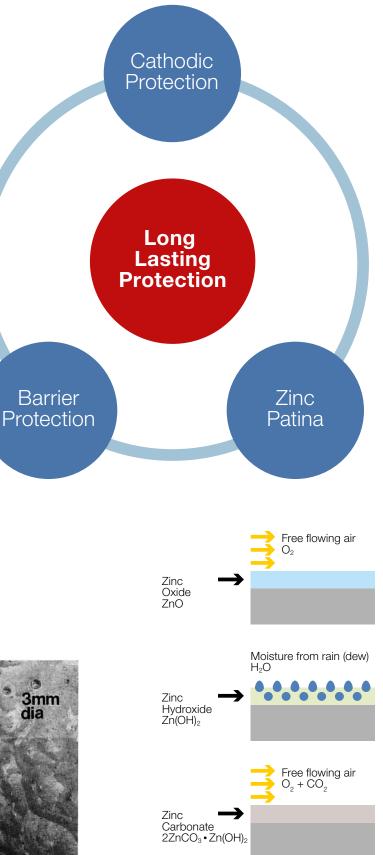
Above: The zinc patina begins its development with exposure to oxygen in the atmosphere. Moisture from rain or humid air reacts with this layer to form zinc hydroxide. This layer then reacts with carbon dioxide present in the atmosphere to form the tightly adherent, insoluble zinc patina.

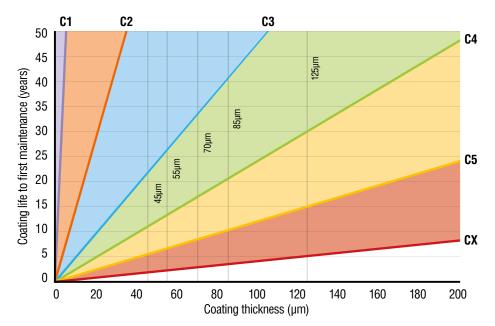
The chart shows that steel with an initial coating thickness of 85μ m in a C4 corrosivity zone will have an expected life to first maintenance of 20 - 40 years.

The life of a hot dip galvanized coating is (to a first approximation) proportional to its thickness, which is normally a function of the article's steel thickness.
